## SOME EARLY RESTORATION OF PARTS WHILST WAITING

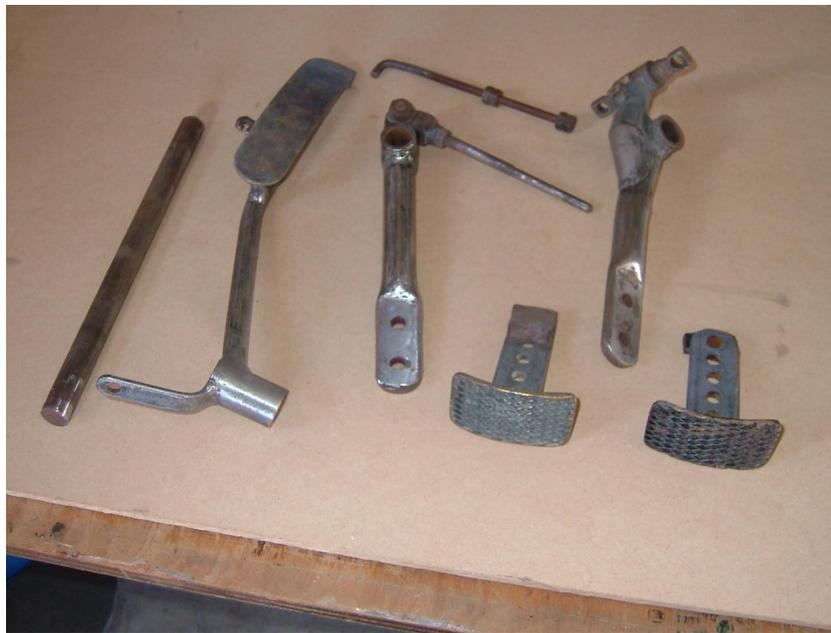
The three pedals are suspended from a shaft running in front of the first bulkhead and operate master brake and clutch cylinders bolted to the rear of the bulkhead. Pushrods pass through the bulkhead. The whole lot is nicely designed and very well made. The assembly is very light, the pedal shafts are thin tube and the foot pads are light sheet with a light mesh welded over the surface to provide grip. Both vertical and horizontal adjustment of the pads was available by selecting the right combination of a series of holes and then bolting the pads to the shafts. The pedals were very rusty and in typical old racing car fashion had suffered over the years in order to keep the car going. In particular the pads were welded rather poorly to the shafts. By carefully grinding the welds I was able to separate the components without cutting away any of the parent metal. The shafts and other components were carefully sanded and filed to clean up the surfaces and then packed for future nickel plating and reassembly. Most of the work was done by hand with final cleaning in a small workshop sand blaster I bought recently. The hand filing and sanding produces a smooth surface. The sand blaster leaves it slightly rough. It is also satisfying to hand restore the components rather than just blasting them with a machine.

**Components of the pedal system laid out after cleaning and grinding all the non original welds. February 2007. Parts will be carefully stored for nickel plating at a later date. The anti slip mesh welded to the pads can be seen.**

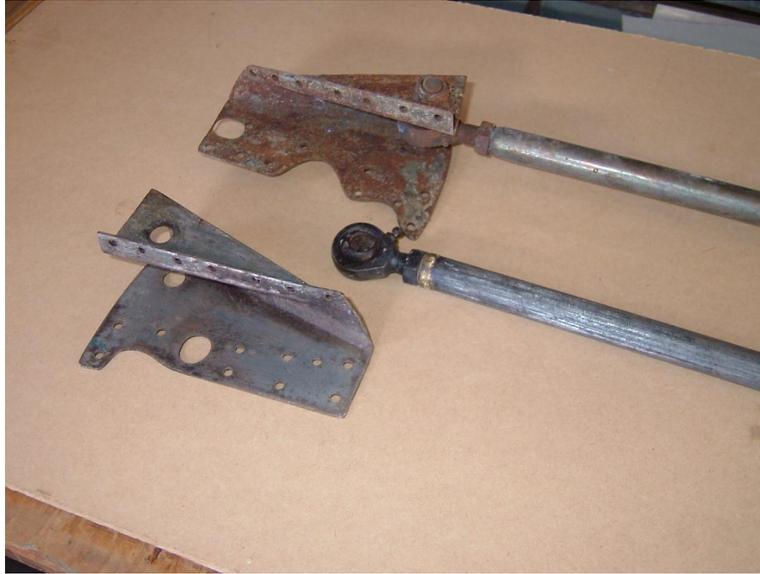
The brackets supporting the lower rear radius rods from the chassis were the next item tackled. They are fabricated from 18g sheet and made with some care and thought. The radius rod is attached with a spherical joint which is nicely located by a turned spacer on each side. Through racing stresses and probably over tightening the brackets were distorted and from years of neglect they were heavily rusted. Preliminary restoration consisted of cleaning and straightening ready for future painting and riveting to the tub.

**Radius rod and brackets before and after cleaning and straightening. The spherical joints will all be replaced. Brackets will be painted and later pop riveted to the monocoque and radius rods will be nickel plated. Note that the brackets are opposites and are not exactly the same.**

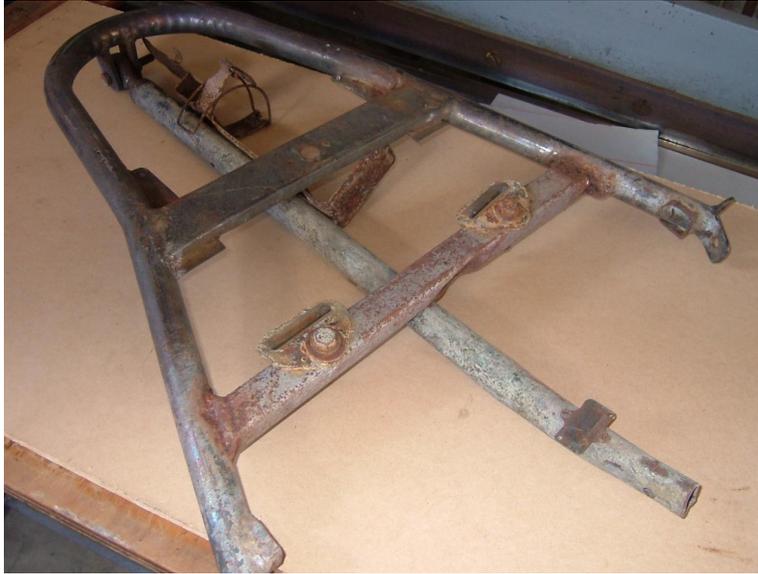
**A**nother piece on the list for early clean-up is the roll bar bolted across the tub behind the drivers head. The original has again been subject to some rather nasty welding to mount the seat belt and thoughtlessly had the fire extinguisher bolted to it. It will be cleaned and prepared although it is likely that the roll bar might have to be extended to meet current safety regulations.

**There's nothing pretty about this. The roll bar has been welded, bent, and neglected. It will be cleaned and prepared but most likely will have to be replaced to meet current safety regulations. There must be a better place for the fire extinguisher bracket.**
